INSPECTION REPORT

| Client: Four Star Ventures | Location: DaPaJo Construction Limited | Date: April 05, 2012 |
| Parts Examined: 4 1/2" elevator | S/N: JKL-05-21-12 | |

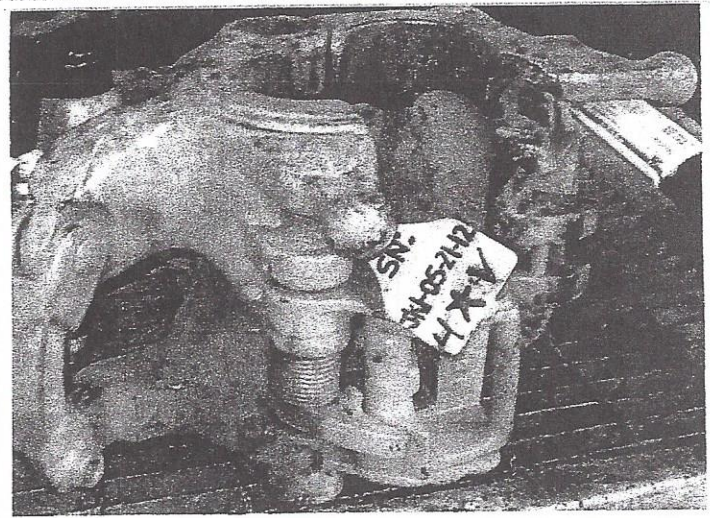
Photos:

Test Results:
 No defects found at time of inspection.
