# Ideal Inspection

## INSPECTION REPORT

Client: Four Star Ventures	Location: DaPaJo Construction Limited	Date: April 05, 2012
P.O. :	Work Order : 2139n	Report : 3484
Page : 1 of 1	Rig or Unit :#16	Inspection: Magnetic Particle
Parts Examined: 7" elevator	S/N: 20241	
Surface Condition: Painted	Material Temperature: 20° Celsius	
Procedure: MPI-DPJ-001	Code: ASME Section V, ASTM E709	
Equipment: Parker B 310 Contour Probe, PM-50 Permanent Magnets		
Method: Magnetic Particle, AC Continuous, Wet Colour Contrast Method		
Test Medium: Magnaflex 7HF prepared bath

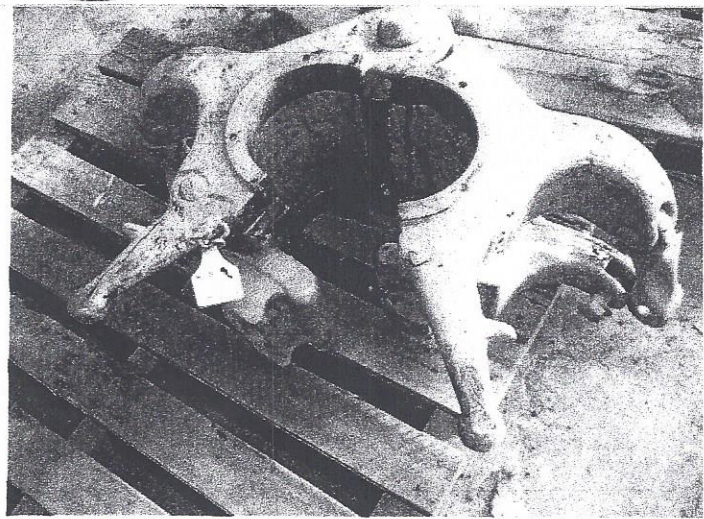
Photos:

Test Results:  
No defects found at time of inspection.
